Replacing blades and/or shear pins after hitting an obstacle

- Iseki SG19 or SG22 with SCMA48 or SCMA54 Mower Deck

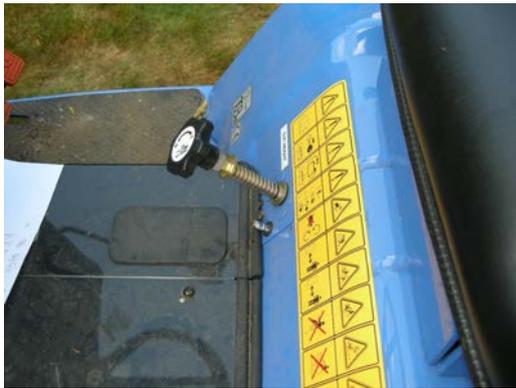
Picture 1: Cut set to lowest setting

2. Un-pin and turn the trailing wheels on the deck to right angles to the direction of travel. This helps you slide the deck out later.
3. Set cutting height to minimum height, start motor, lower deck fully down, switch off motor.

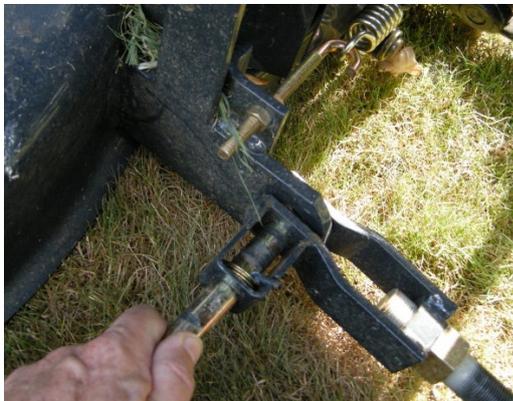
Picture 2: Trailing Arm pins eased out

4. Using the mole grips or large multi-grip pliers, ease out two large deck pins connected to trailing arms each side. (NB: These have in-situ split-pin catches to hold them back.)

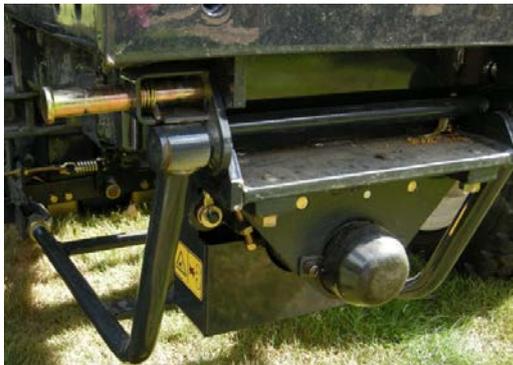
Picture 3: Front Pin eased out

7. Go to front of machine and ease out single large pin which allows front trailing arm to be swung down with the lever and detached from front of mower.

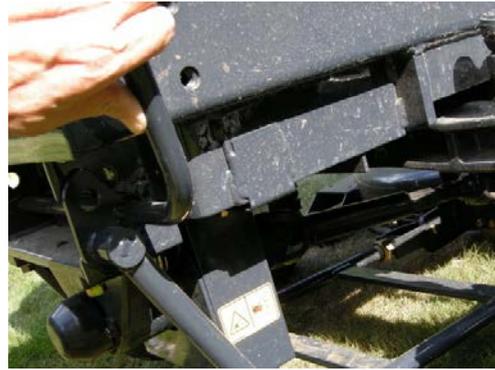
Picture 4: Lever on tractor LHS brought forward to disengage front connection

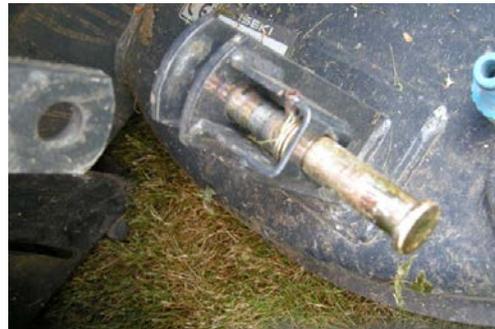
Picture 5: Trailing arm pins eased out and arms disconnected

8. Ease out the two large trailing arm deck pins to detach the trailing arm link.
9. Push the top of the deck chute as low as possible and secure (on either side) with the mole grips. (Picture 7).

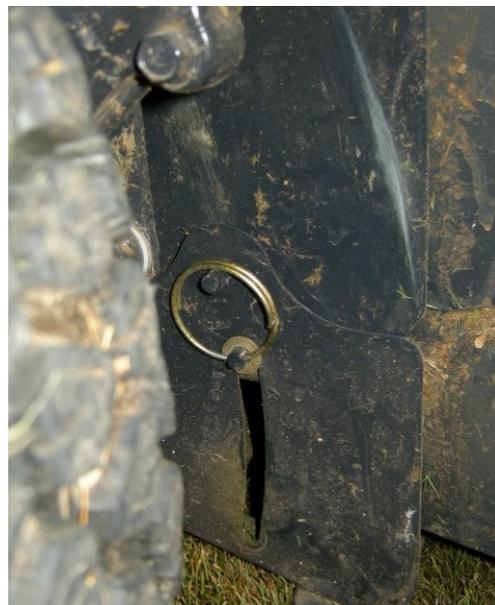
Picture 6: Rear Chute held down with large hoop (already in place)

5. Start motor, and operate deck lift lever to lift arms to highest position, switch off motor.
6. Push central bottom chute collector behind the deck as low as possible and secure using the in-situ large ring clip. (Picture 6).

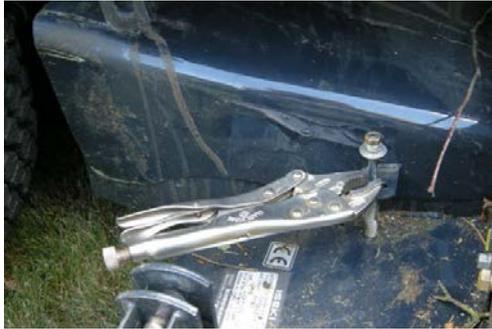
Picture 7: Deck Chute held down with mole grips

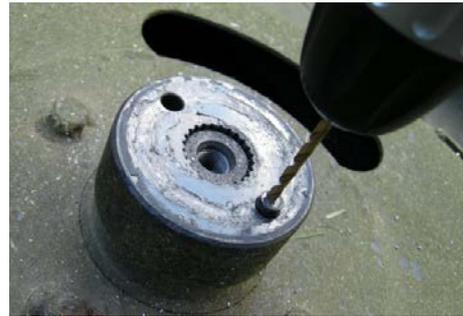
Picture 11: Drilling out sheared pins

- b. Drill with 3 -4 mm HSS drill down the centre of each pin until the pin starts to rotate with the drill bit and can be removed after the drill is detached, (see Picture 11), OR, after the drill has gone in to 6mm, removing and then a suitable size self-tapping screw is inserted until very tight, then the broken smaller part can be removed.

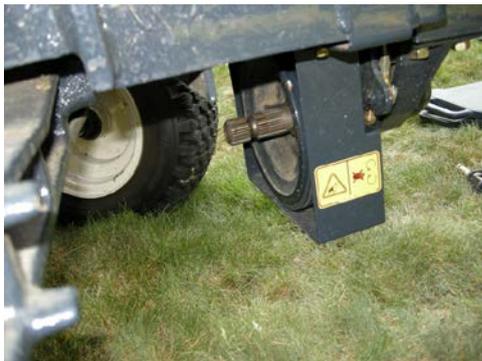
Picture 8: Front power take-off shaft after deck shaft uncoupled

10. **Important: Mistake often made here.** See Picture 8 first; it shows where the power drive is detached from the machine power take off point (PTO). Detach the power shaft at the front of the shaft by sliding the circular collar mechanism at the front of the power shaft, towards the rear. This allows the splined shaft to slide backwards and fall free of the PTO.

6. **Important: Mistake often made here.** See Picture 8 to remind you of the reconnection point; it shows where the power drive is attached to the machine (PTO). Attach the power shaft at the front of the shaft by sliding the circular collar mechanism at the front of the power shaft, towards the rear. This allows the splined shaft to slide on and connect to the PTO. Attach it by pushing the collar mechanism to the rear, whilst pushing the assembly on to the PTO spline.

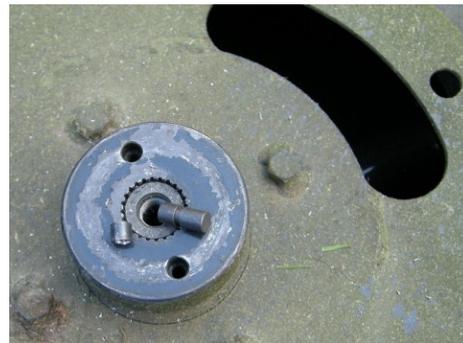
Picture 12: Sheared pin and new pin side by side. NB: short length goes in first.

3. Once the broken pieces are removed, replace with the new shear pins. These should be fitted with the small length in first.
4. Note: Optional, sharpen the blade using a steel file.

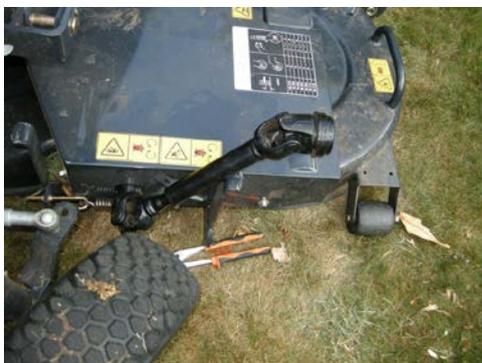
Picture 9: Deck slid out showing power drive shaft and coupler

Slide the deck forward a little until the rear chutes clear each other by a few centimetres. Then slide the deck sideways, out from under the machine. It is a little easier if slid away to the left hand side, with the mower steering set to full right lock. Watch not to catch the rear chutes as the deck slides out, and also watch the power drive coupling as it clears the wheel of the mower.

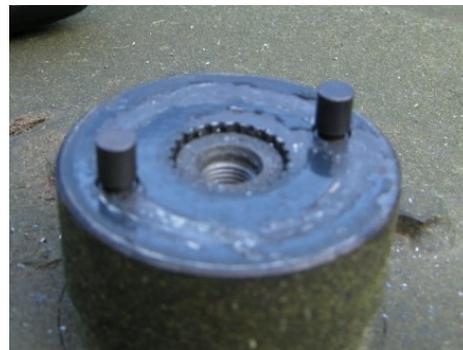
Picture 13: New pins in place

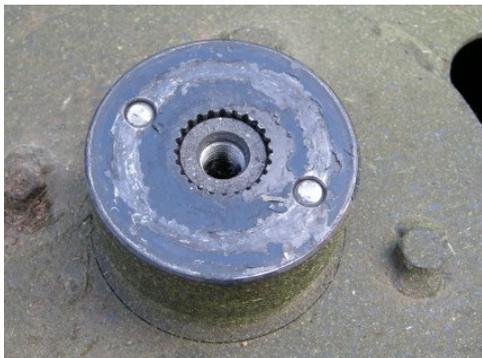
Picture 10: Sheared pins

2. The two shear pins should now be evident. If broken, you need to remove the broken smaller part from the deck shaft platform spindle. This can be done two different ways:

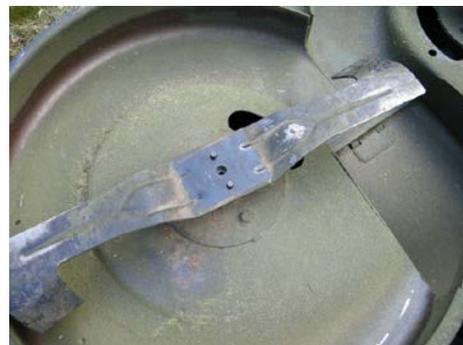
Picture 14: Blade in place over pins

5. Fit the same blade back, the correct way up, and tighten (very tight) using a wooden chock.
6. Rotate the blades to check the blades are not bent and run correctly in relation to the deck.

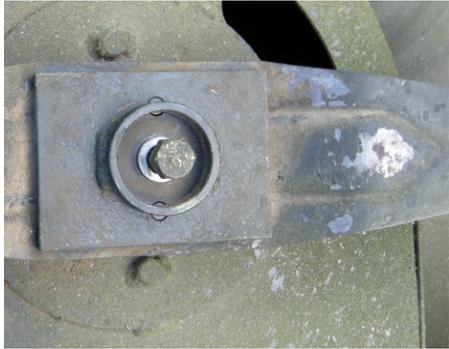
Picture 15: Cover plate and 17mm bolt in place

1. Note the orientation and side for each blade; they are different and must be put back as removed. Remove the central bolt and blades using the 17mm socket and the wood block chock to prevent each blade turning. Turn the bolt anti-clockwise to remove.

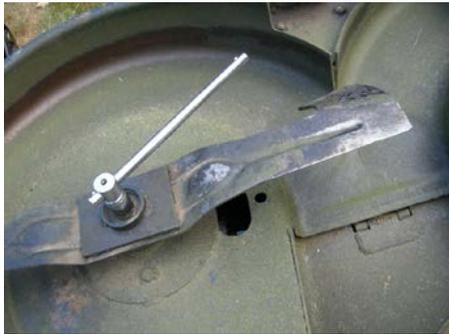
Picture 16: Tightening with the spanner
